Case study – *final draft*
SOCIO-ECONOMIC STUDY – Ystad Sandskog

COMPONENT 3
VALUATION OF THE SHORELINE
MESSINA PROJECT

This case study is made within the Messina project. The purpose is to demonstrate a practical application of economic analysis in coastal management. The case study is based on existing data and many shortcuts have been taken and simplifications have been made. This refers to the fundamental technical prognosis of the implications of erosion and sea level rise. However we hope that this first outline can serve as inspiration and guidance for further case studies.

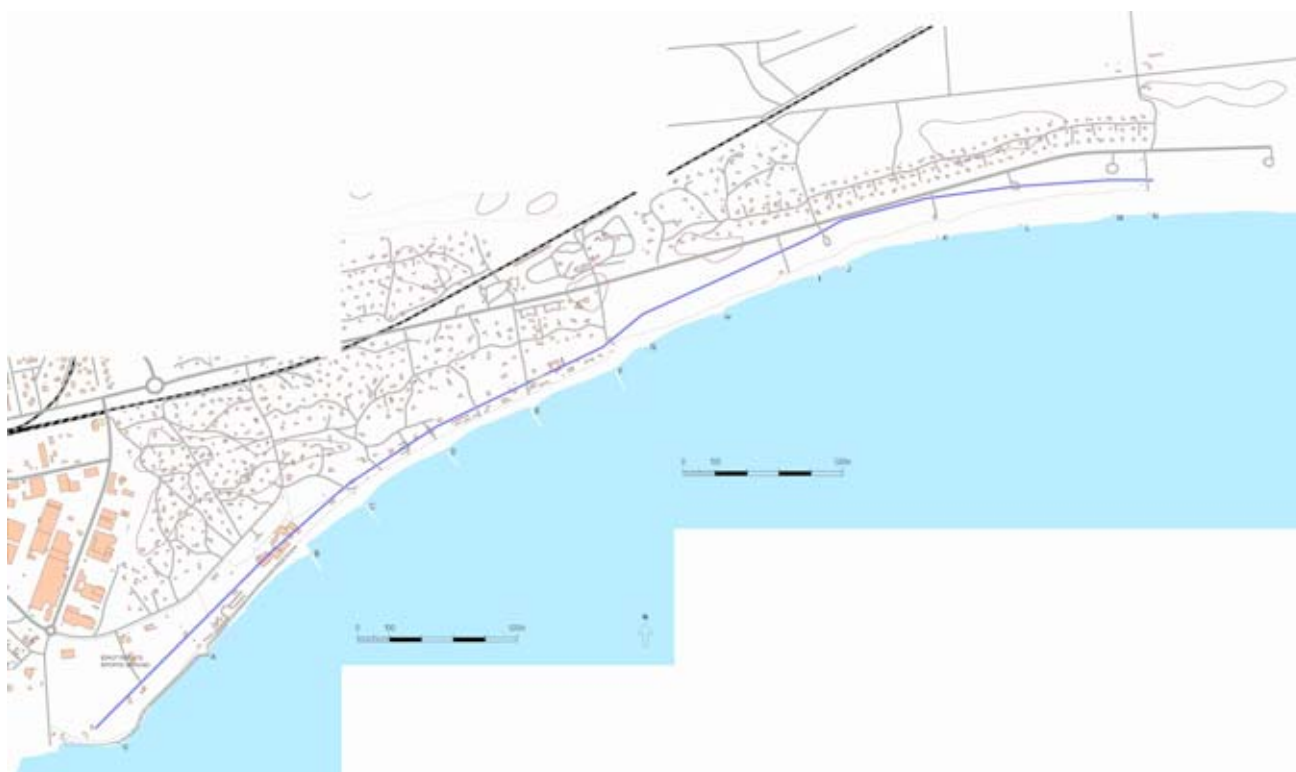
Map 1 – Map over Ystad sandskog coastline with estimated coastline retreat in 100 years if no actions are taken.

The prognosis regarding the position of the coastline in 100 years if nothing at all is done to protect the coastline is presented in Map1 and Table 1 (detailed maps are available in appendix A).

The analysed coastline is 4 200 m long and the estimated loss of land in the “do nothing” alternative is 415 000 m² (an average 98 m of coastal retreat).

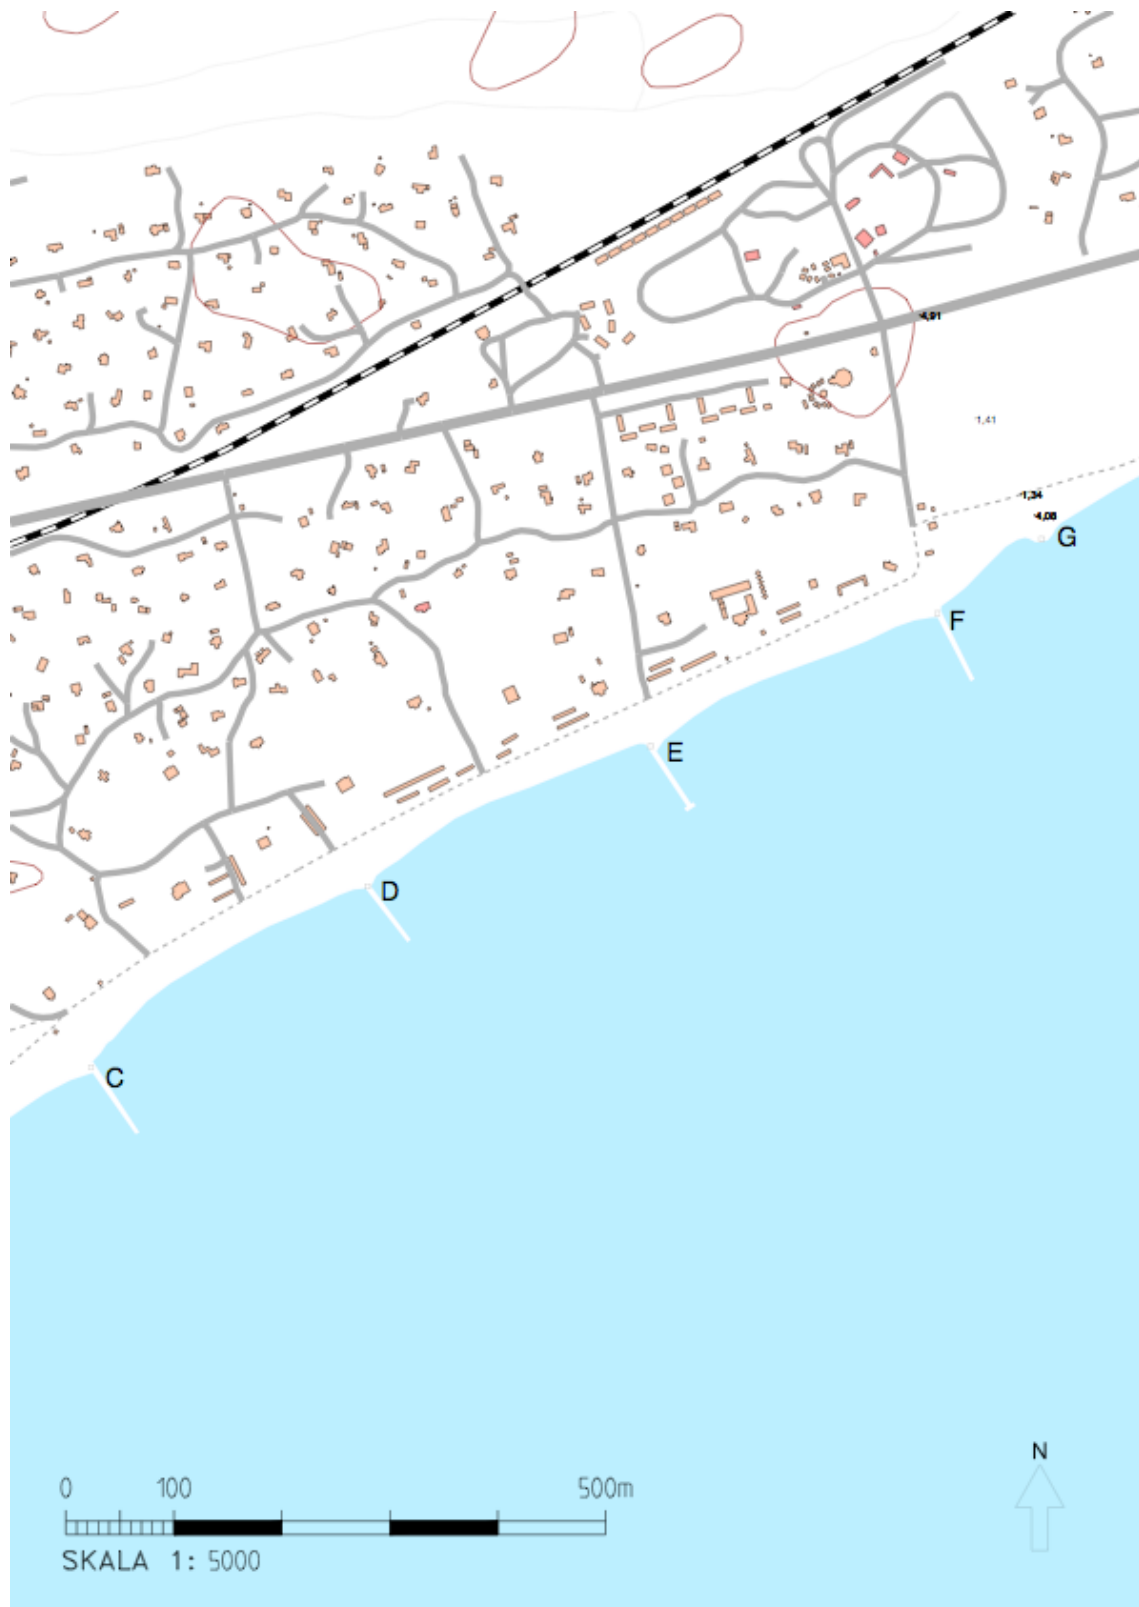
Map A-3. Intersection parts C-G

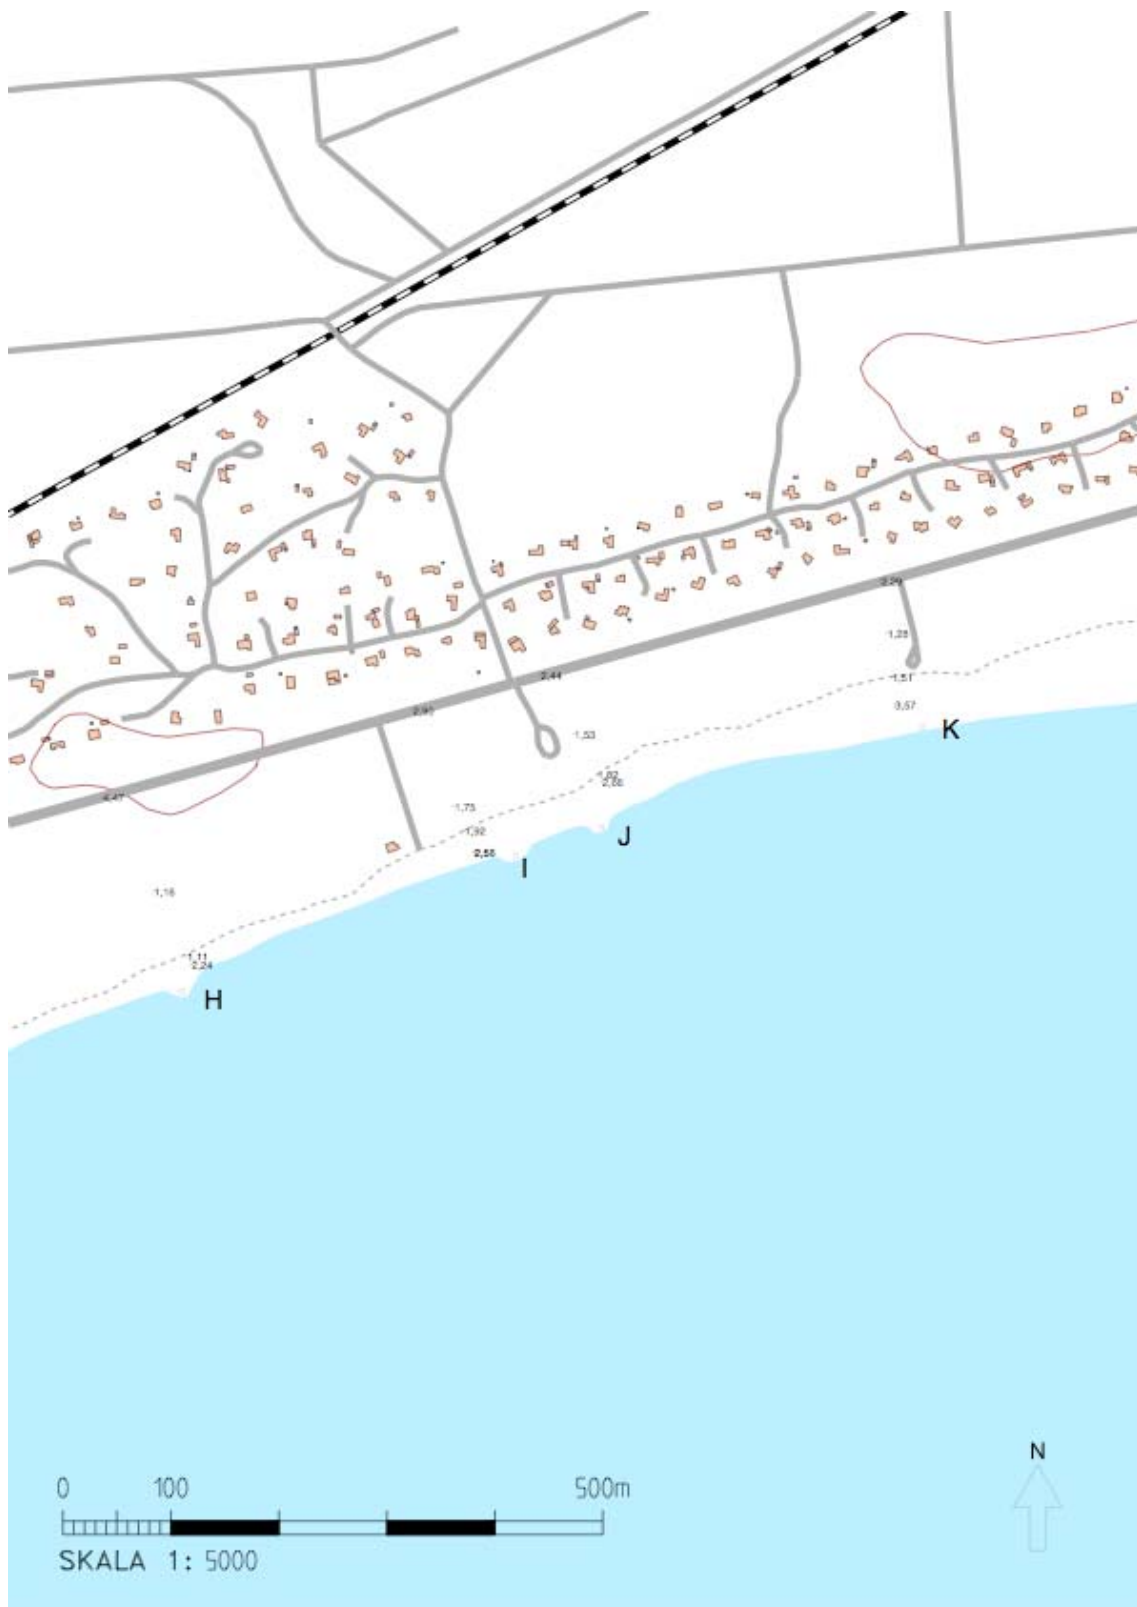
Map A-4. Intersection parts H-K

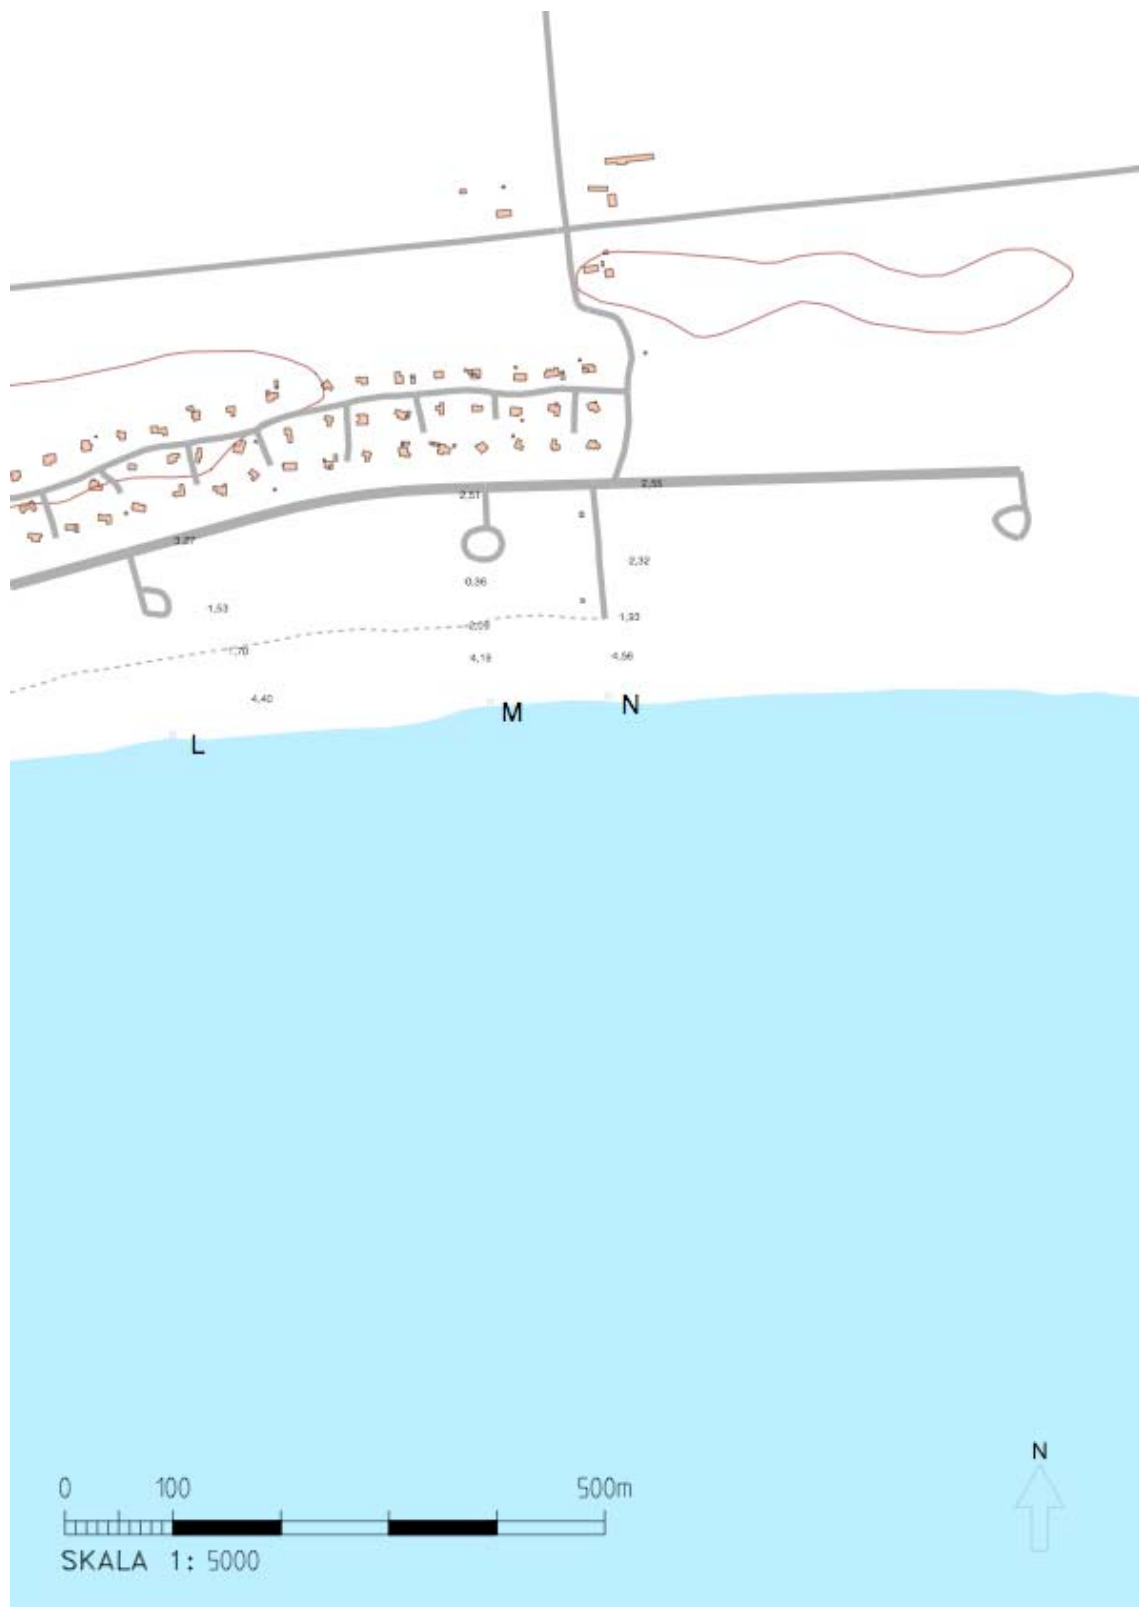
Map A-5. Intersection parts L-N

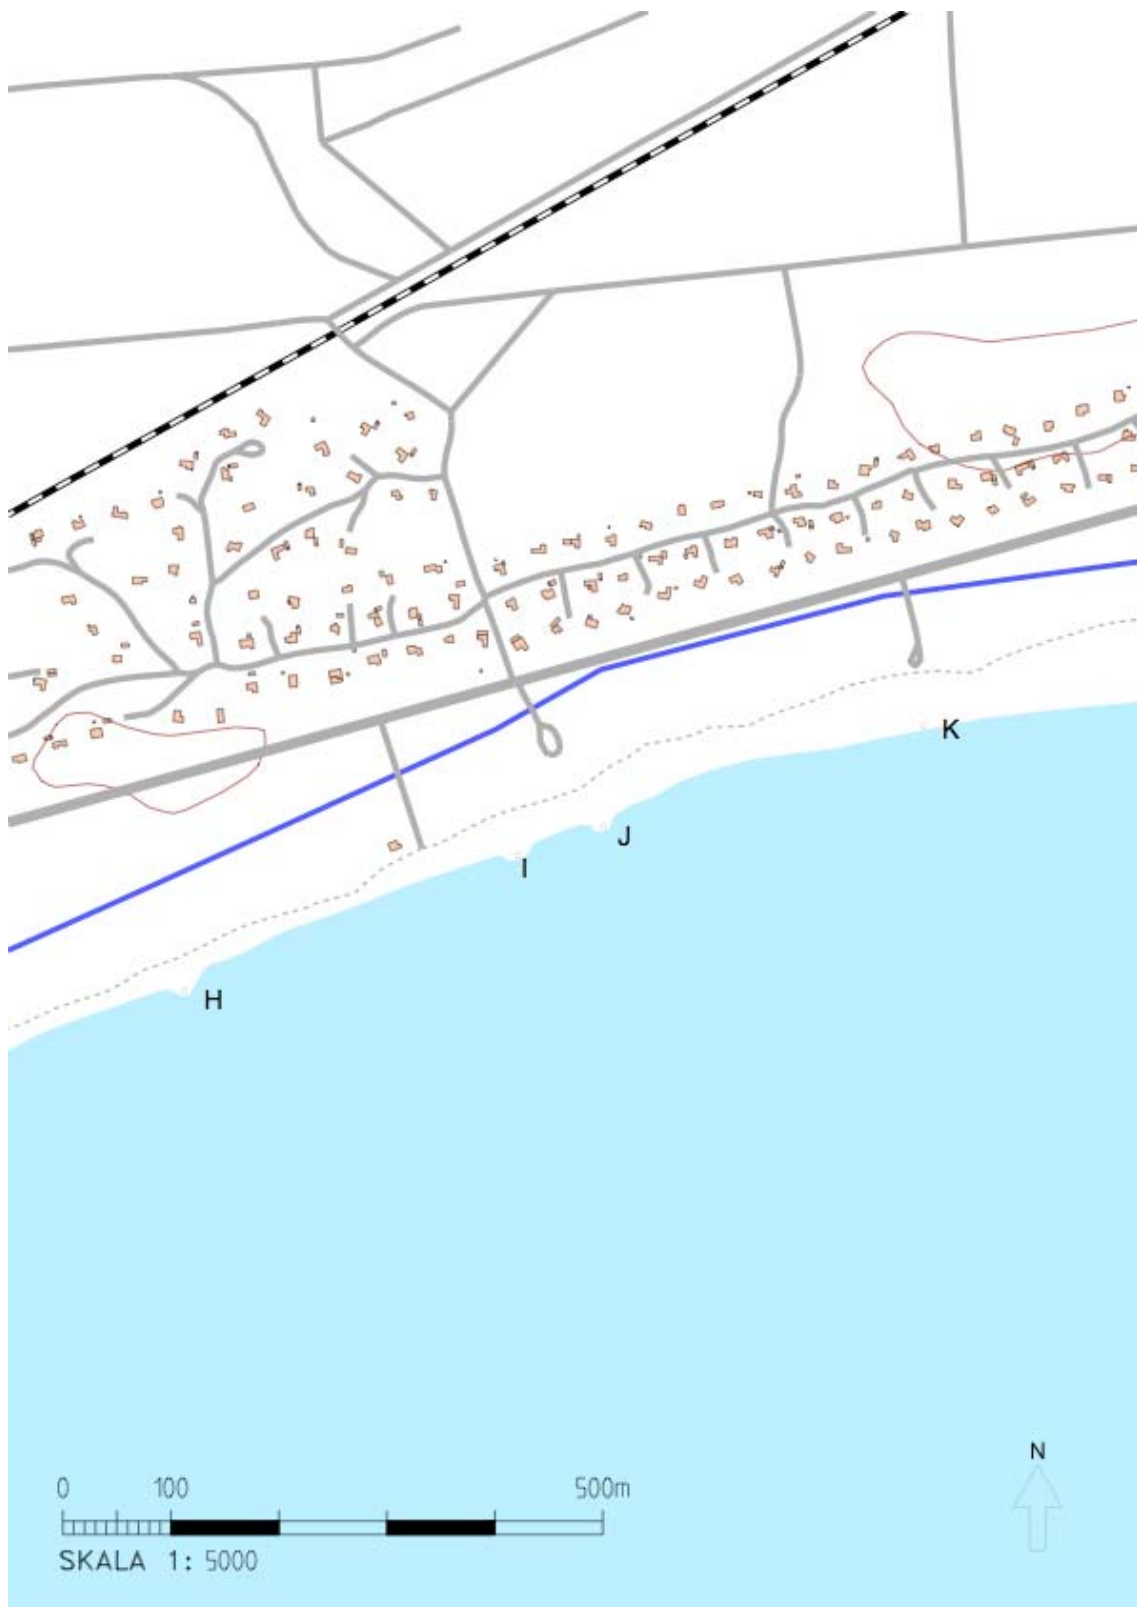
Map A-8. Estimated coastline year 2100 without any measures to protect the coast. Intersection H-K.

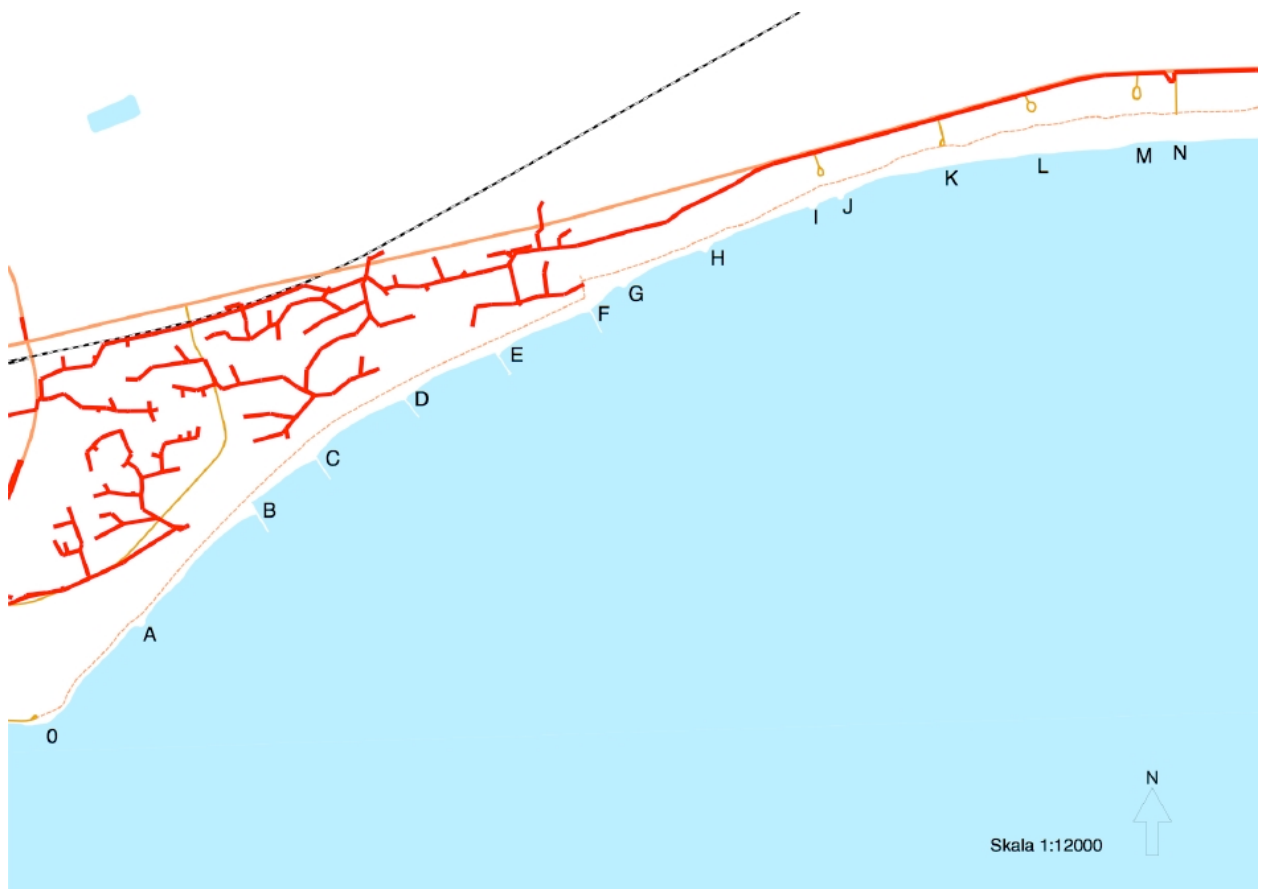
Map A-10. Main water supply pipes in the area.
